CAPITOL LAKE

Adaptive Management Plan

Reference Estuary Study and Biological Conditions Report

Fall 2006

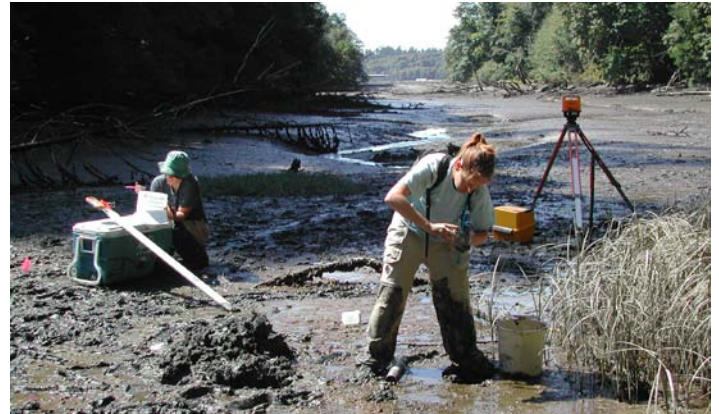
Field data collection. Ellis Cove in Priest Point Park. August 2005

At each estuary a total of 16 to 21 field sampling points were randomly located. There were a total of 90 sites across the five estuaries. Measurements were taken on the following: 1) Vegetation - percent cover; species, and type, 2) Sediment texture - sand, silt, and clay 3) Salinity, 4) Temperature, 5) Dissolved oxygen concentration, and 6) pH. The location and elevation of each sampling point were established using global positioning system (GPS). Sediment cores and empty or dead invertebrate (*insects and shellfish*) shells were collected for later lab analysis. The field work was undertaken during August and September 2005.
